Architectural Survey of Pershing Elementary School, Fort Leonard Wood, Missouri

Sunny E. Adams and Adam D. Smith

August 2013

Final Report

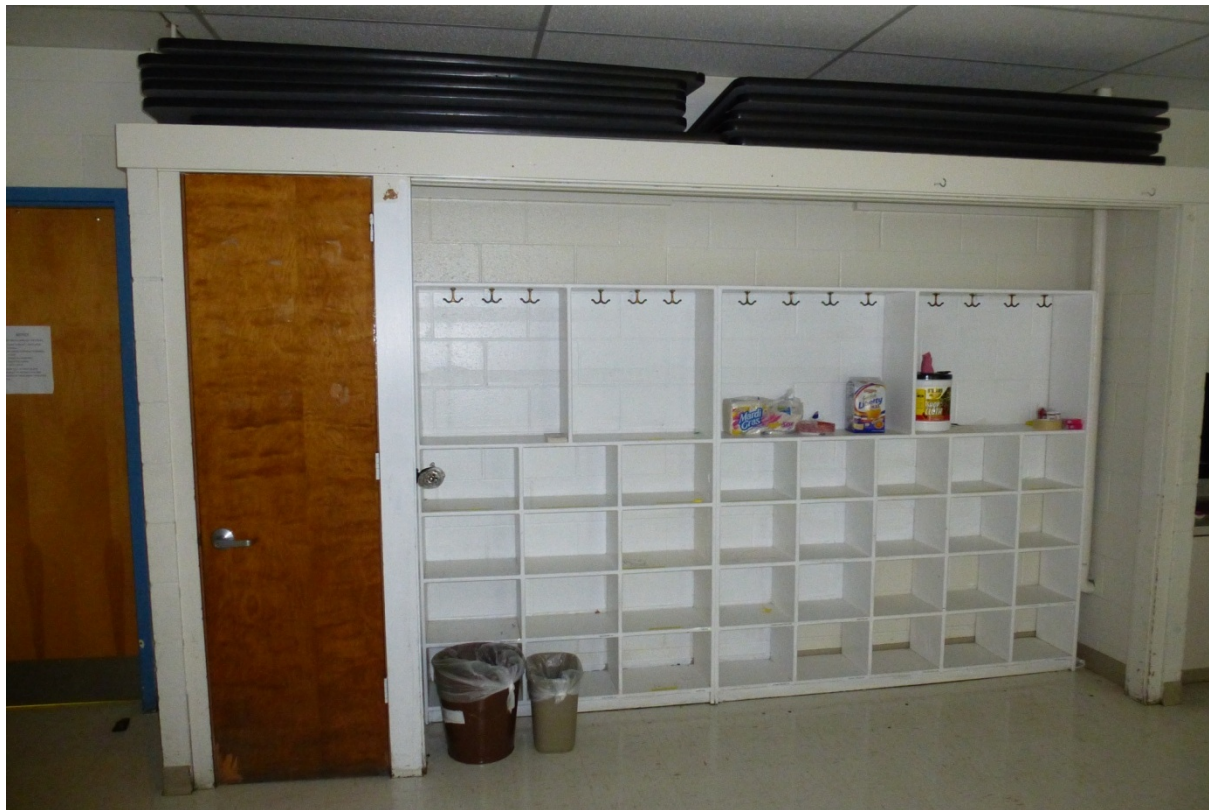
Photo 116. Original wardrobe and closet door with new hardware (1957 addition) (ERDC-CERL, 2012).

Classrooms: There were originally ten classrooms designed and constructed as part of the 1957 addition; however, with the construction of the 1984 addition, there are only nine classrooms intact. The design and construction of these classrooms are similar to the original 1955 classrooms. Each classroom has replacement vinyl tile flooring, replacement acoustic drop-tile ceilings, replacement light fixtures, and replacement wood doors that provide access from the corridor to each classroom (photos 113 and 115). Each classroom has a wall of a combination of metal panels and two windows with original glazed-tile windowsills (photos 109 and 132). The classrooms each have an original built-in wood wardrobe. The wardrobe is open with no doors; however, there is a small teacher's closet adjacent to the wardrobe and all of the original wood closet doors are intact (photos 108, 112, 114, 116, 126, 128, and 133). Along one wall in each classroom are the original wood chalkboard frames.

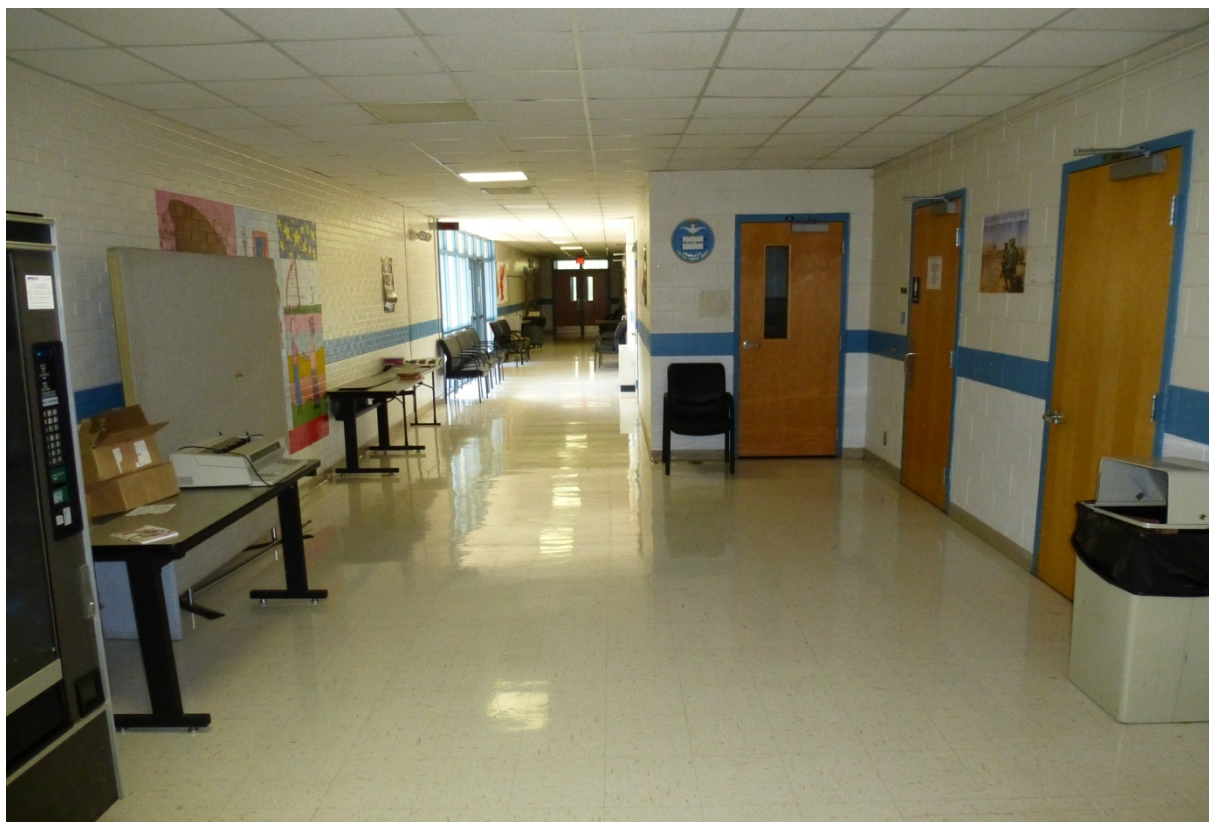
Photo 117. Looking west down 1957 corridor addition toward the 1984 vestibule (ERDC-CERL, 2012).

Corridors: The 1957 corridor is L-shape in plan and stretches north and west (photo 117). The corridor has acoustical drop-tile ceilings, concrete block walls, and vinyl tile floors (photo 56). The brick north end of the original structure is visible and is connected to the concrete block addition walls (photos 122 and 123). The leg of the L-shaped corridor that expands west is where another main entry is located (photo 124).

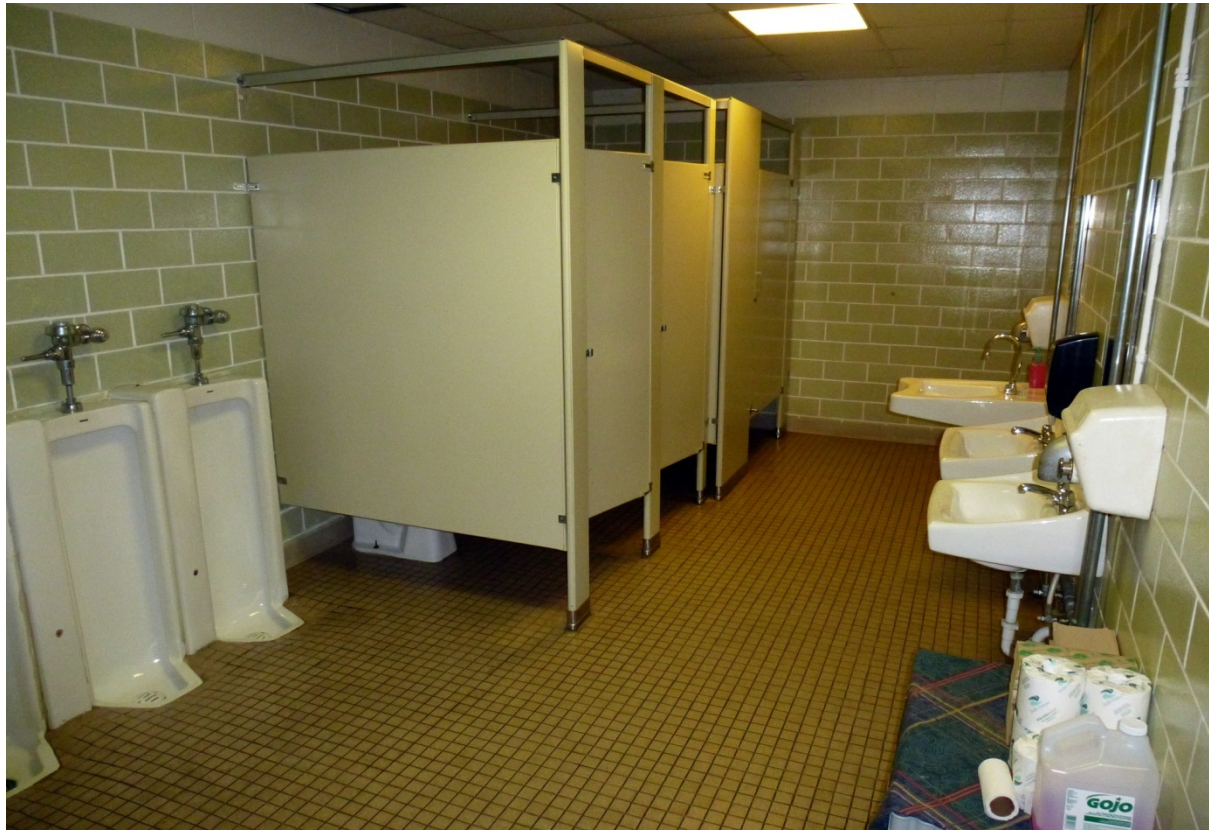
Photo 118. Boys' restroom with original urinals and glazed-tile walls (1957 addition) (ERDC-CERL, 2012).

Boys' Restroom: Restroom consists of the original mosaic tile floor, original glazed-tile walls, original urinals, and original toilets (photo 118).

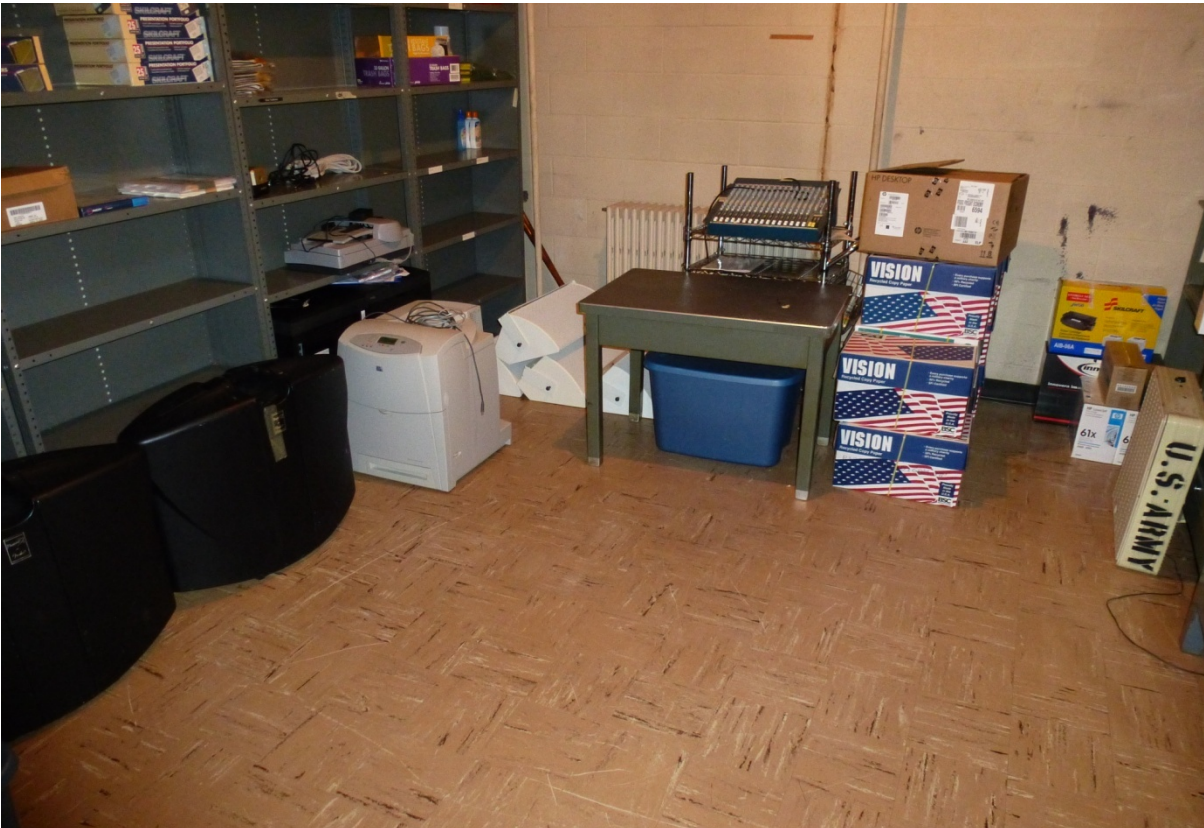
Photo 121. Storage room with original asbestos tile flooring (1957 addition) (ERDC-CERL, 2012).

Bookstore: This room is now used as a storage room and is located west of the girls' restroom. Originally the room was one large space, but a partition wall has been constructed to divide it into two rooms. The one room has original asbestos tile floor (photo 121).

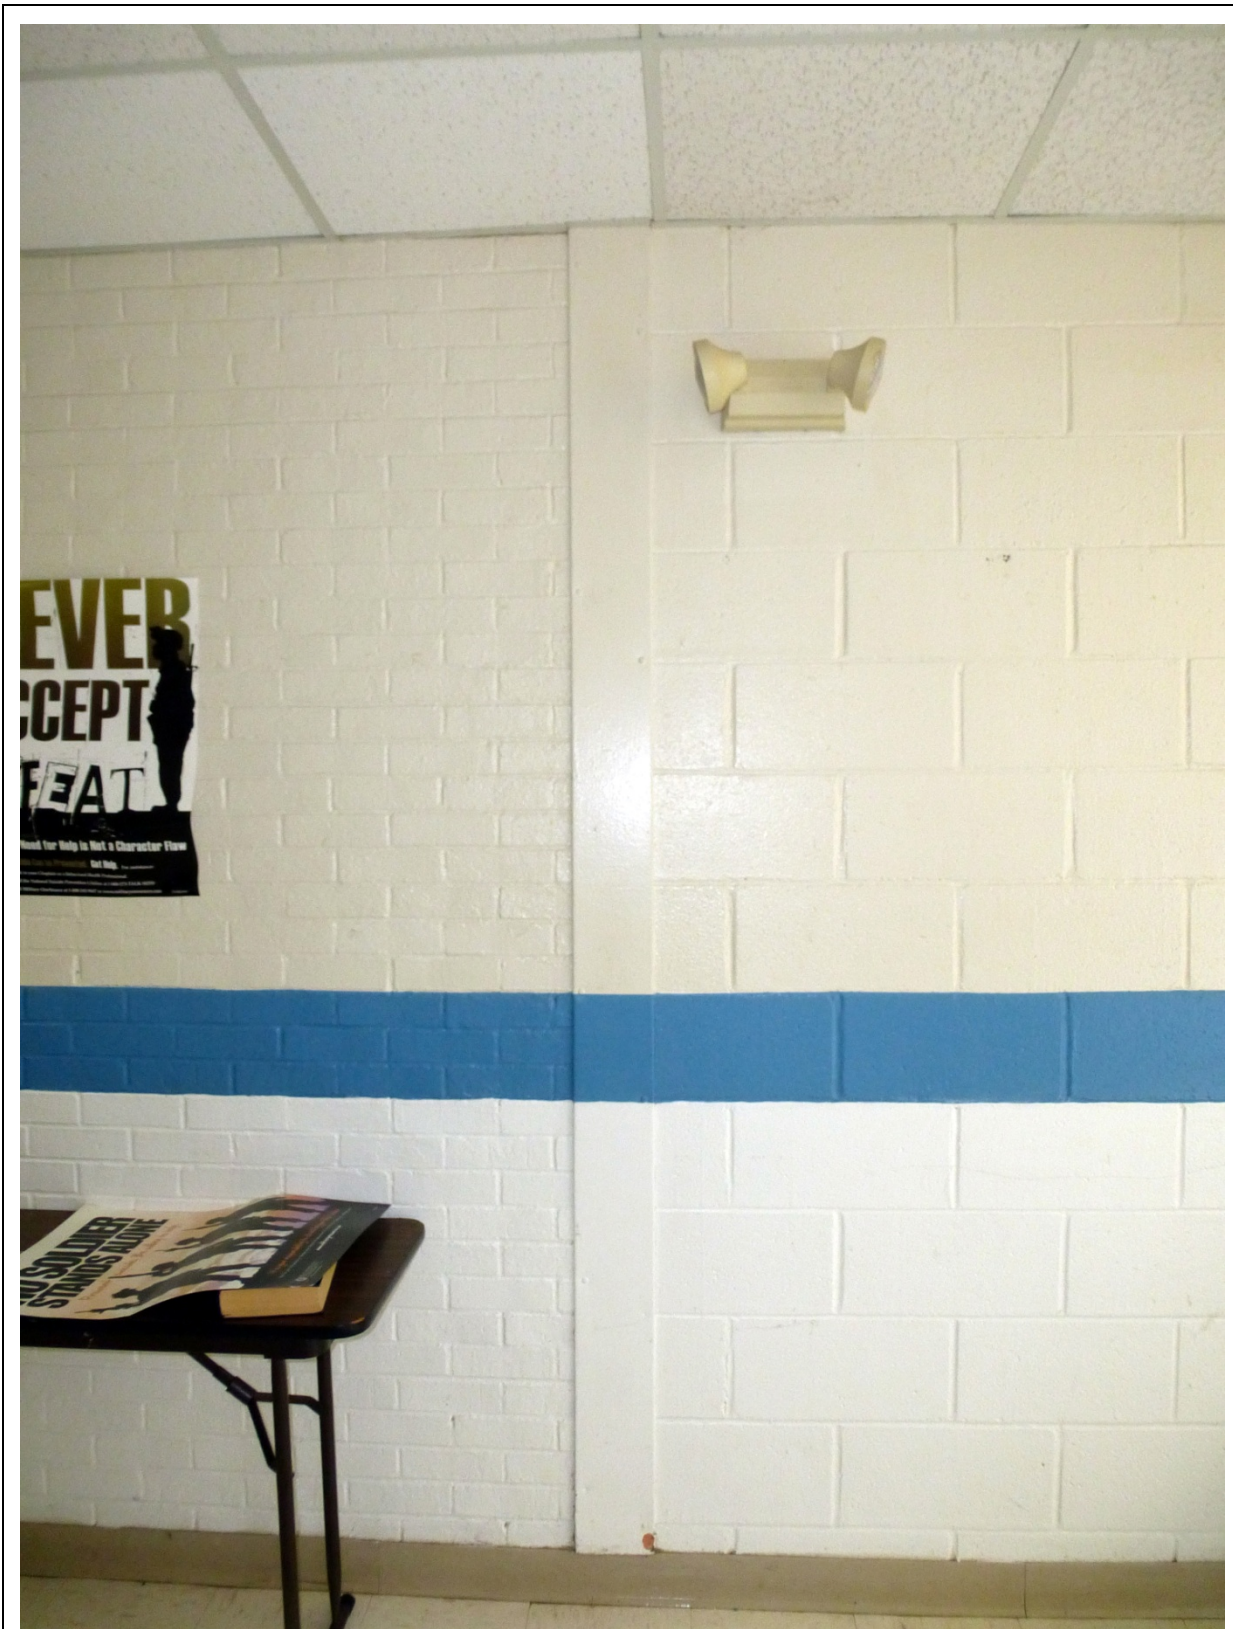
Photo 123. Closeup of the original north exterior wall of original school on left, connected to concrete block wall of the 1957 addition (ERDC-CERL, 2012).

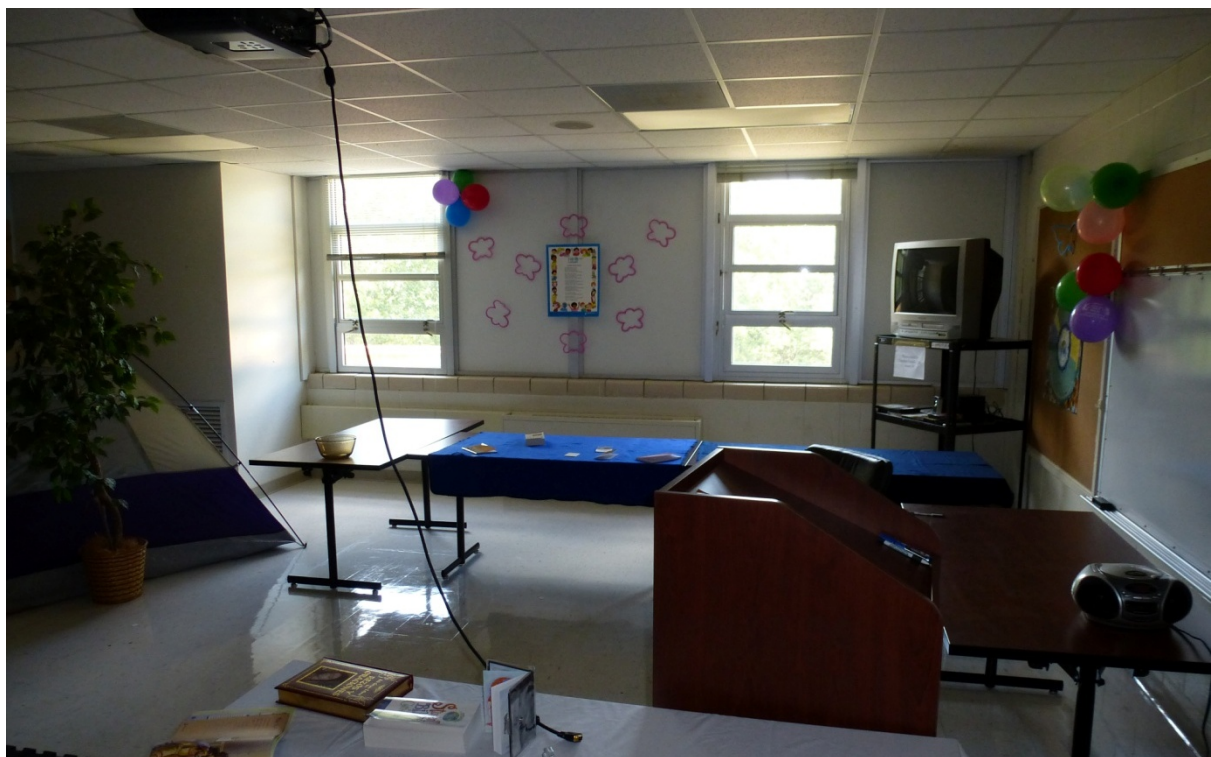
Photo 125. Classroom (1957 addition) (ERDC-CERL, 2012).

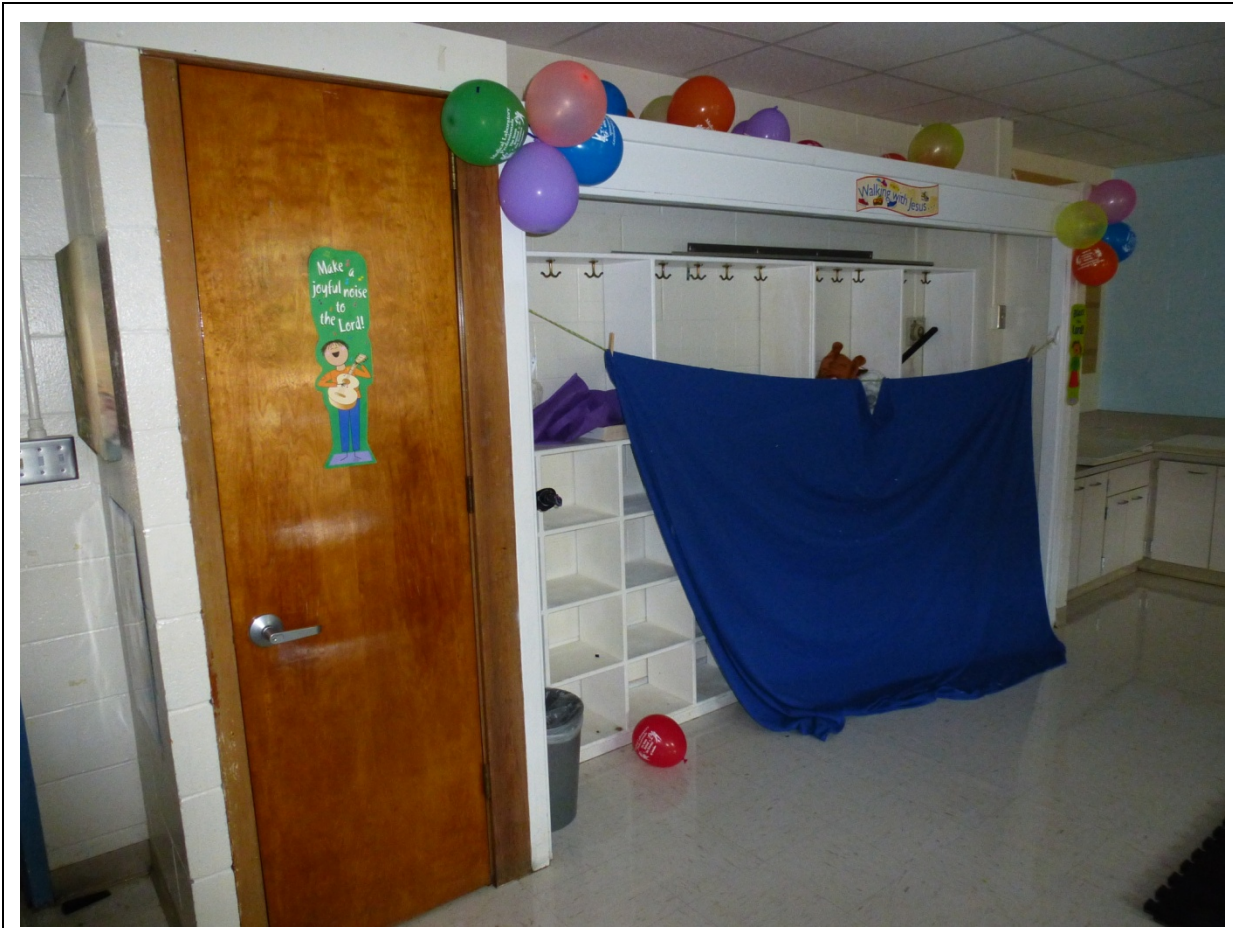
Photo 126. Wardrobe in classroom (1957 addition) (ERDC-CERL, 2012).

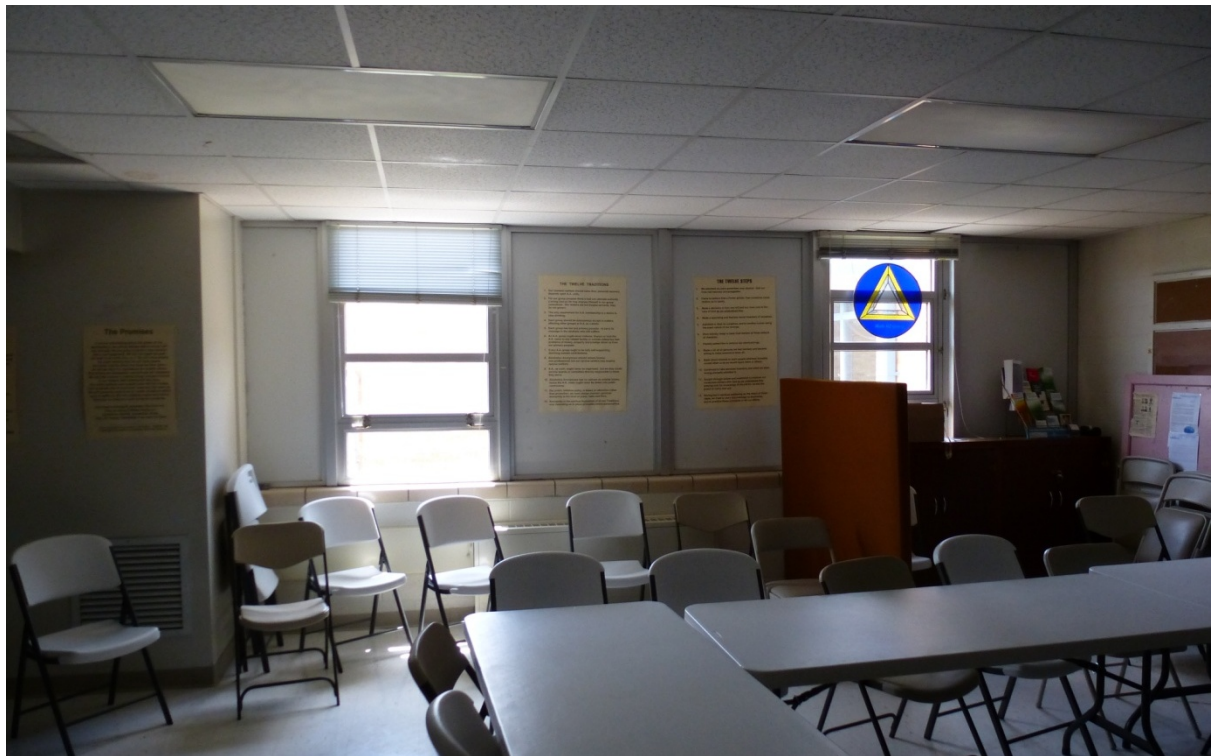
Photo 130. Classroom (1984 addition) (ERDC-CERL, 2012).

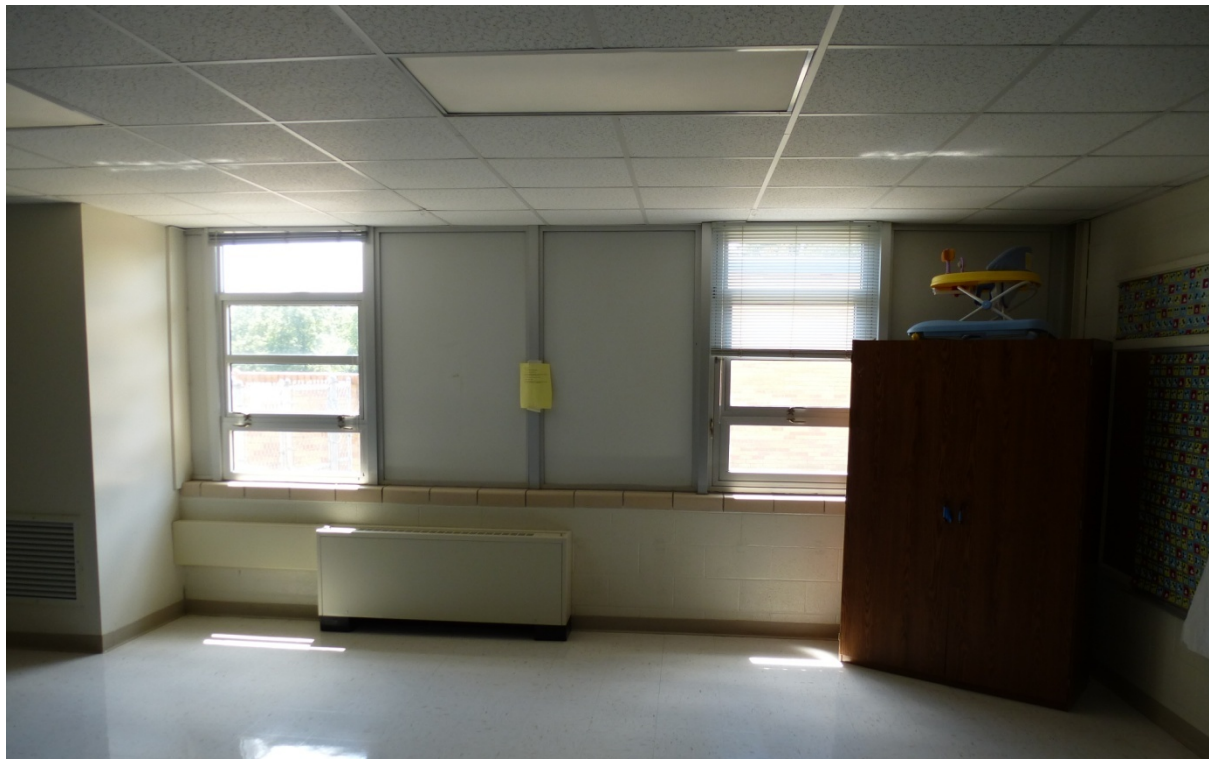
Photo 132. Classroom (1957 addition) (ERDC-CERL, 2012).

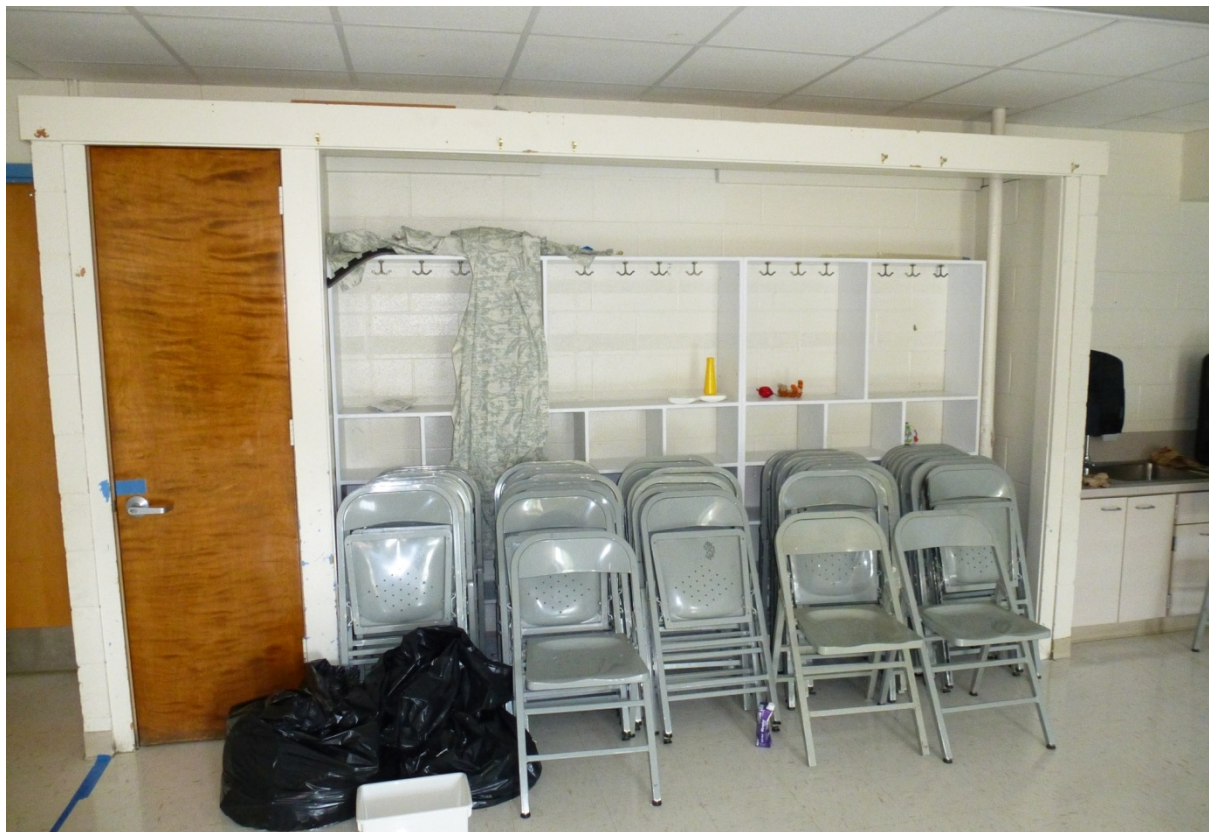
Photo 133. Original wardrobe and closet door with new hardware in classroom (1957 addition) (ERDC-CERL, 2012).

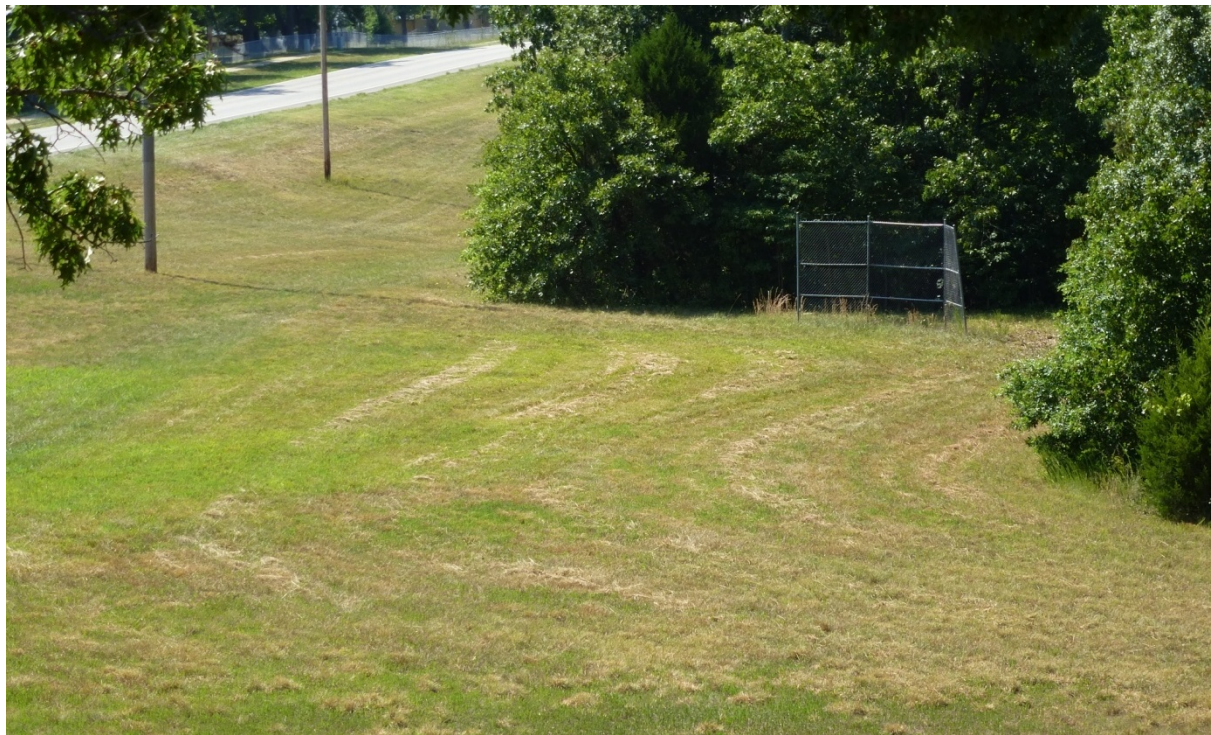
Photo 134. Athletic field on the south side of the school (ERDC-CERL, 2012).

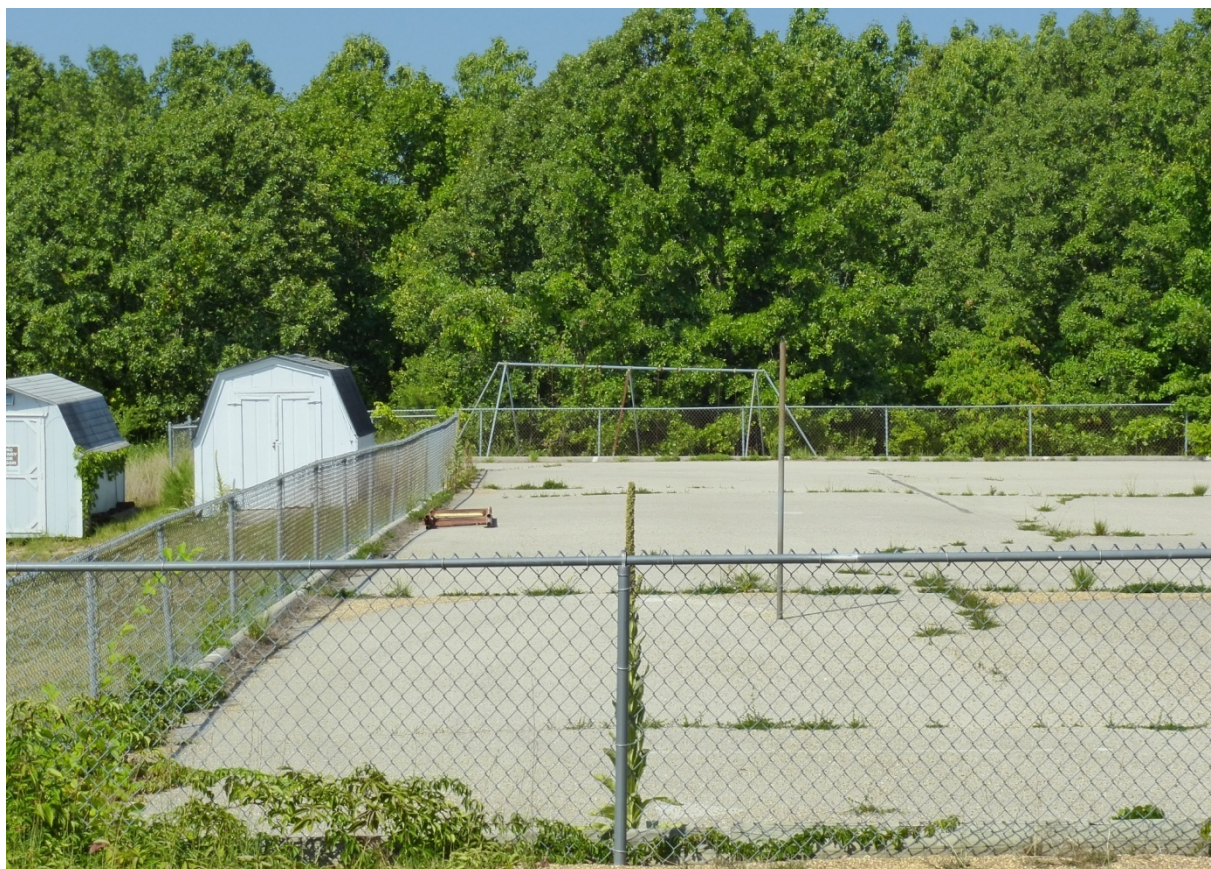
Photo 135. Paved playground on the west side of the school (ERDC-CERL, 2012).

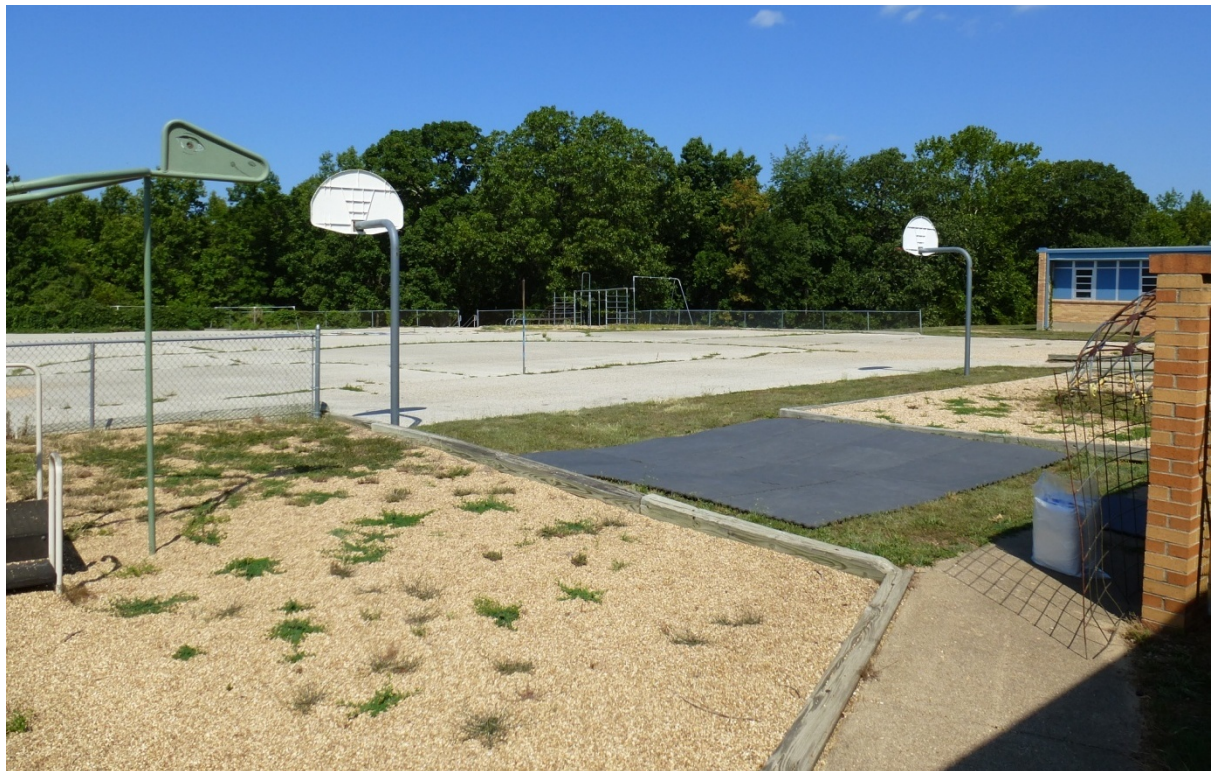
Photo 136. Paved playground area on west side of the school (ERDC-CERL, 2012).

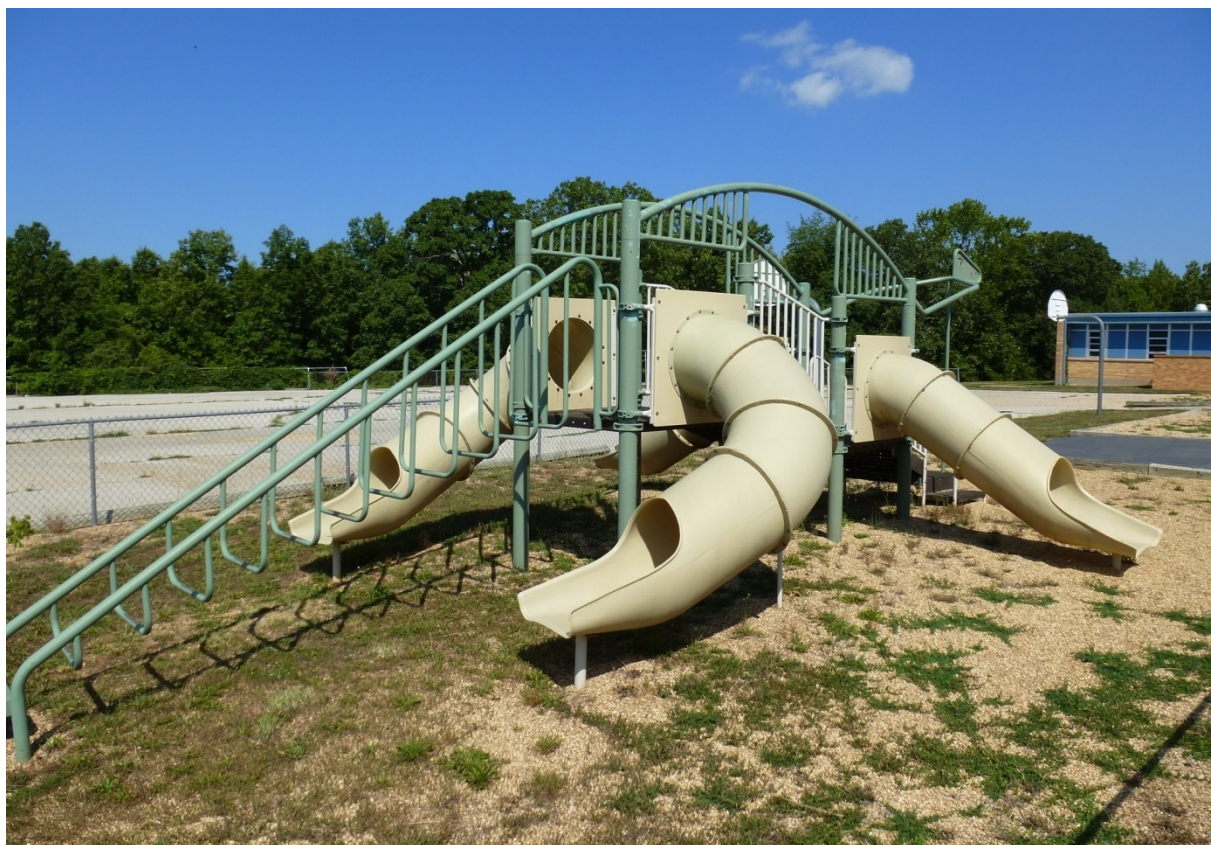
Photo 137. Newer playground equipment on the west side of the school (ERDC-CERL, 2012).

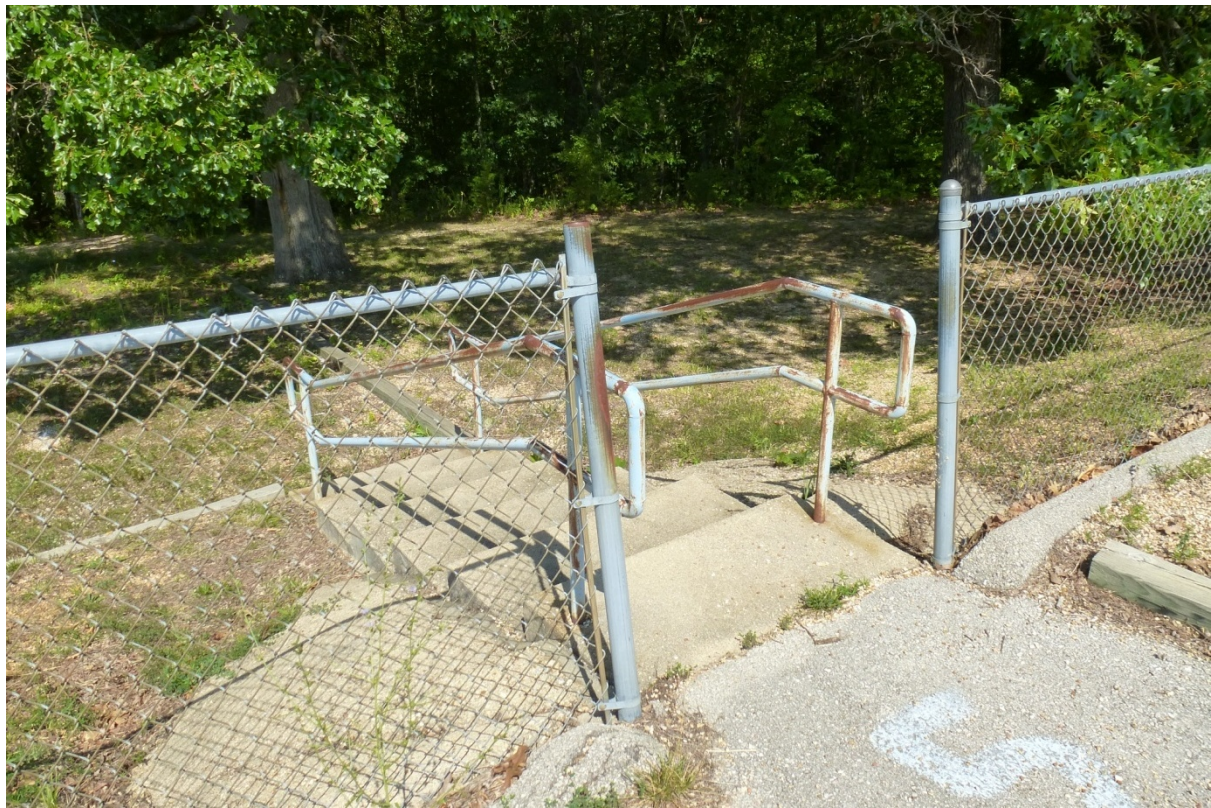
Photo 138. Steps leading down to the play area outside of the fenced playground (ERDC-CERL, 2012).

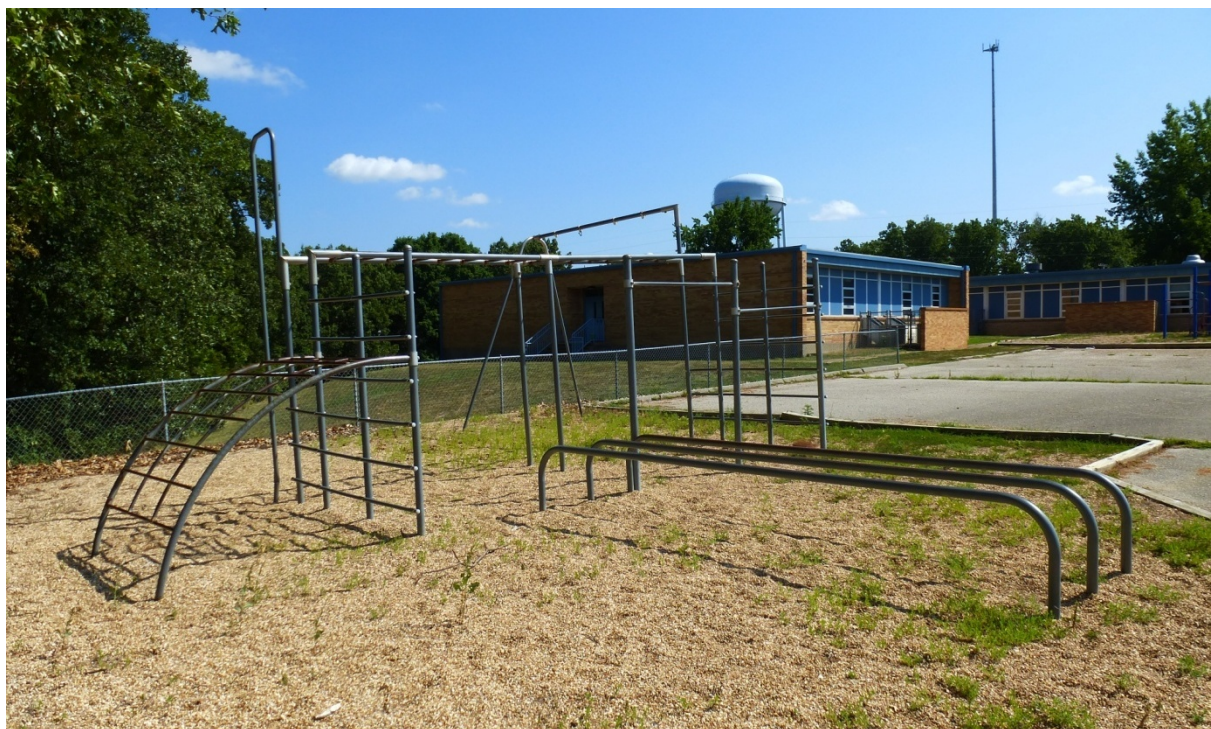
Photo 139. Older playground equipment on the west side of the school (ERDC-CERL, 2012).

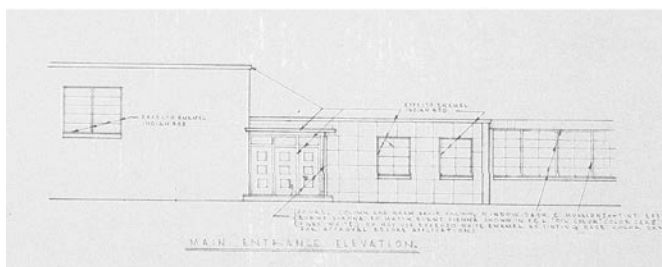
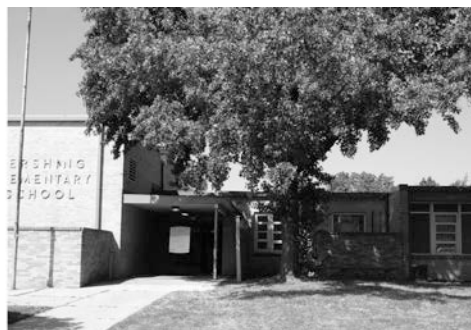
East elevation with main entrance and wall of windows: Original drawing on the left from 1955 with original awning windows compared to the current replacement doors, sidelights, transom, and metal windows.

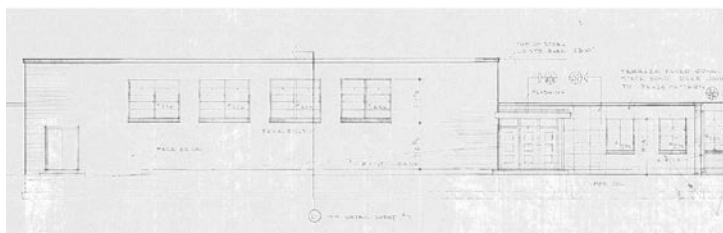
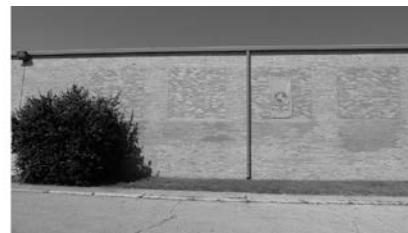
East elevation: Original drawing on the left from 1955 with original multi-pane windows located on the double-height wall of the all-purpose room compared to the current condition of the wall with the removal of the windows and infill brick.

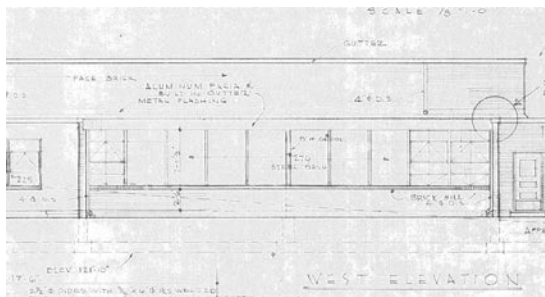
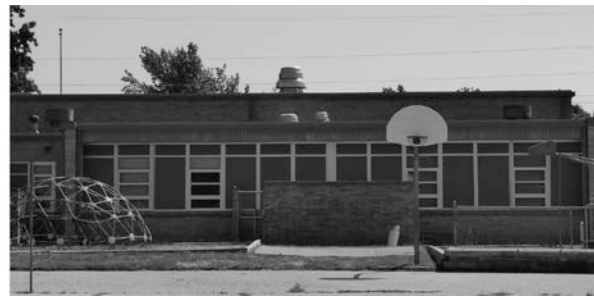
Right side of west elevation: Original 1955 drawing with design of classroom windows compared to the current condition of the elevation with replacement windows and metal panel inserts.

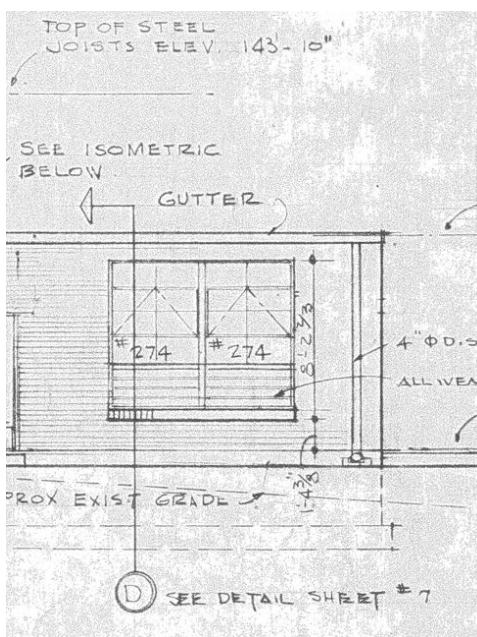
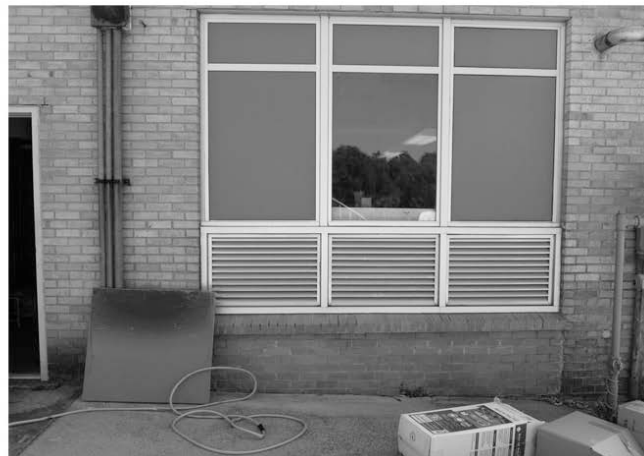
Window comparison: Original drawing on the left from 1955 showing two original multi-pane awning steel sash windows with two metal louvered vents compared to the current replacement bright aluminum and awning windows with porcelain enamel metal panel inserts and new, metal louvered vents.

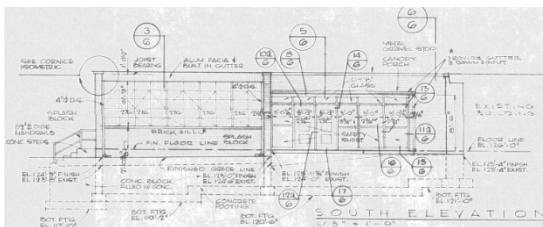
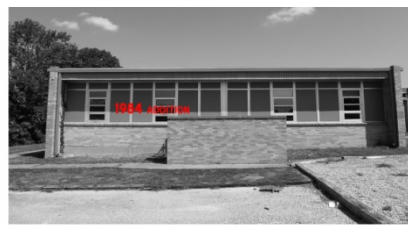
Window comparison: 1957 addition drawing on the left showing multi-pane awning/hopper steel sash windows compared to the current replacement bright aluminum and awning windows with porcelain enamel metal panel inserts. Also, the original doors have been replaced. The image on the right also shows the 1984 classroom addition.

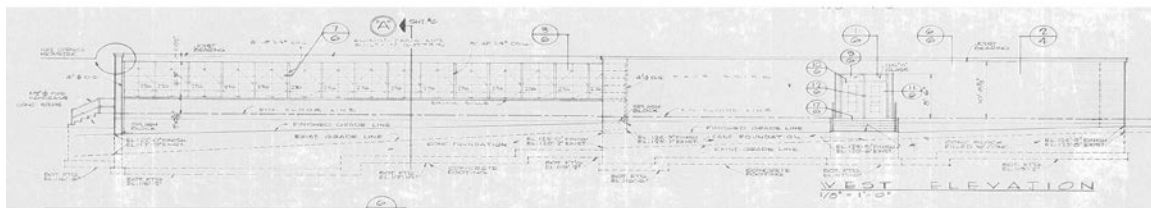
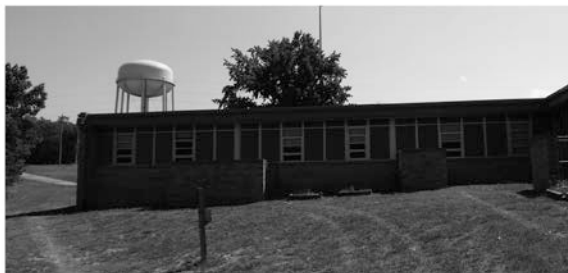
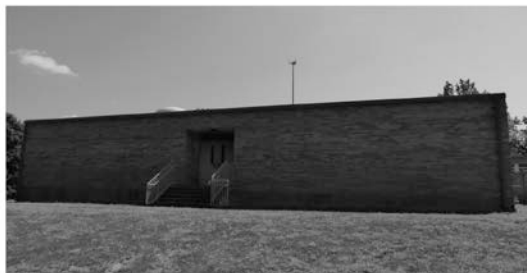
South elevation: 1984 drawing on the top showing the 1957 classroom addition on the left and the 1984 classroom addition on the right compared to the current condition of the building with replacement doors, sidelights, and transom.

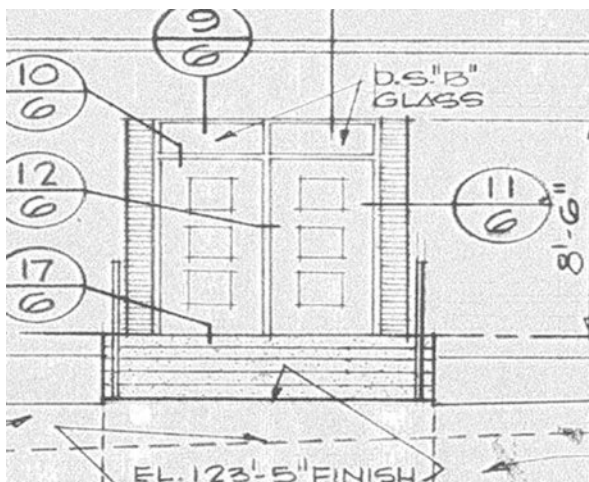
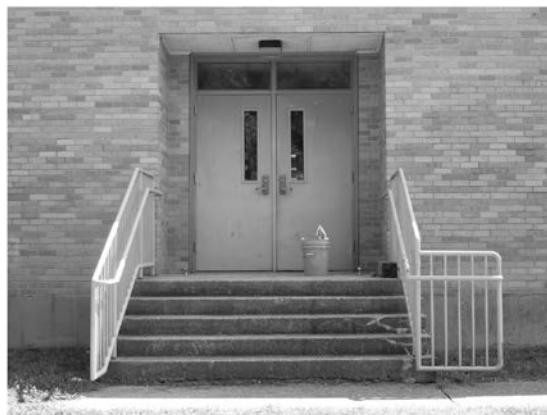
West elevation: 1984 addition drawing on the left compared to the current replacement doors and original transom.

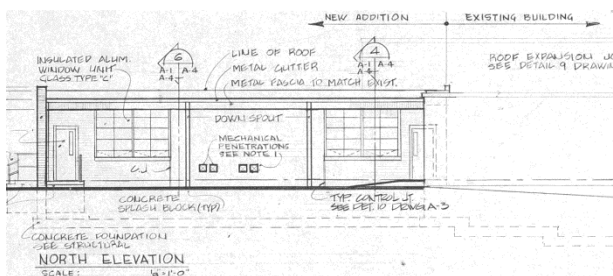
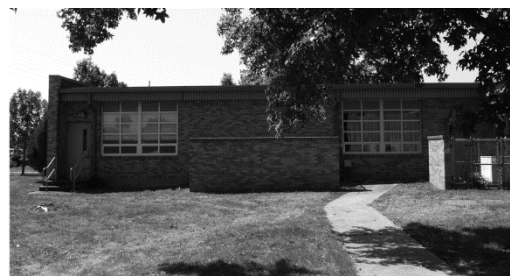
North elevation: 1984 addition drawing on the left compared to the current condition of the left side of the north elevation.

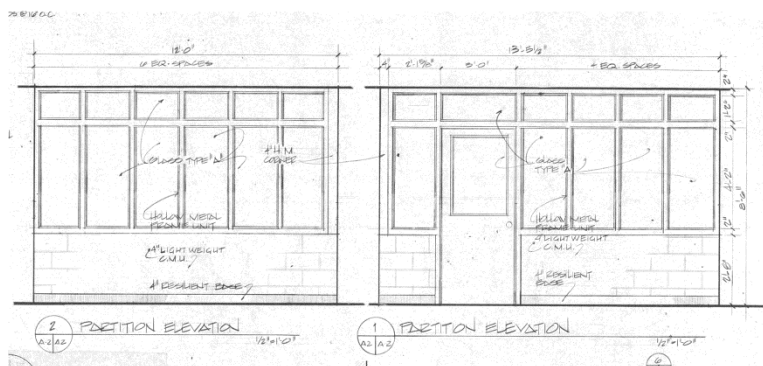
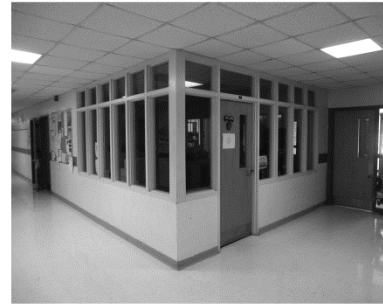
Interior office: 1984 addition drawing on the left compared to the current enclosure of the open office space near the main entry on the east elevation.

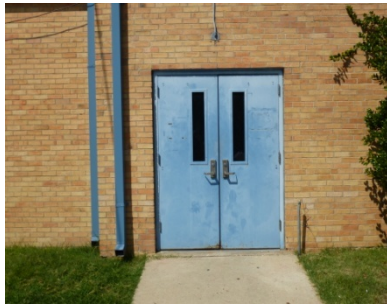
Replacement exterior doors.
